BARRIO HISTORICO

HISTORIC ZONE ADVISORY BOARD

HO-3, HPZ - 141-147 W. Simpson adobe rowhouses

T20CM06162, NOVEMBER 9, 2020

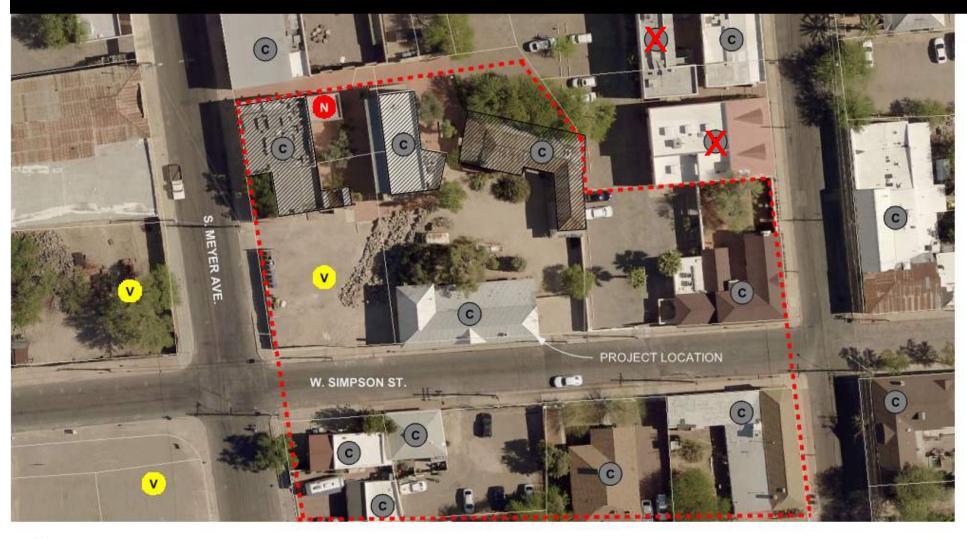
1 HZP AERIAL IMAGE (WITH DEVELOPMENT ZONE DOTTED IN RED, AS PER 5.8)
NOT TO SCALE
